University Environment Committee
Draft Report 17.xx
Visibility at North Loop Road Pedestrian
Crossings

December 14, 2017

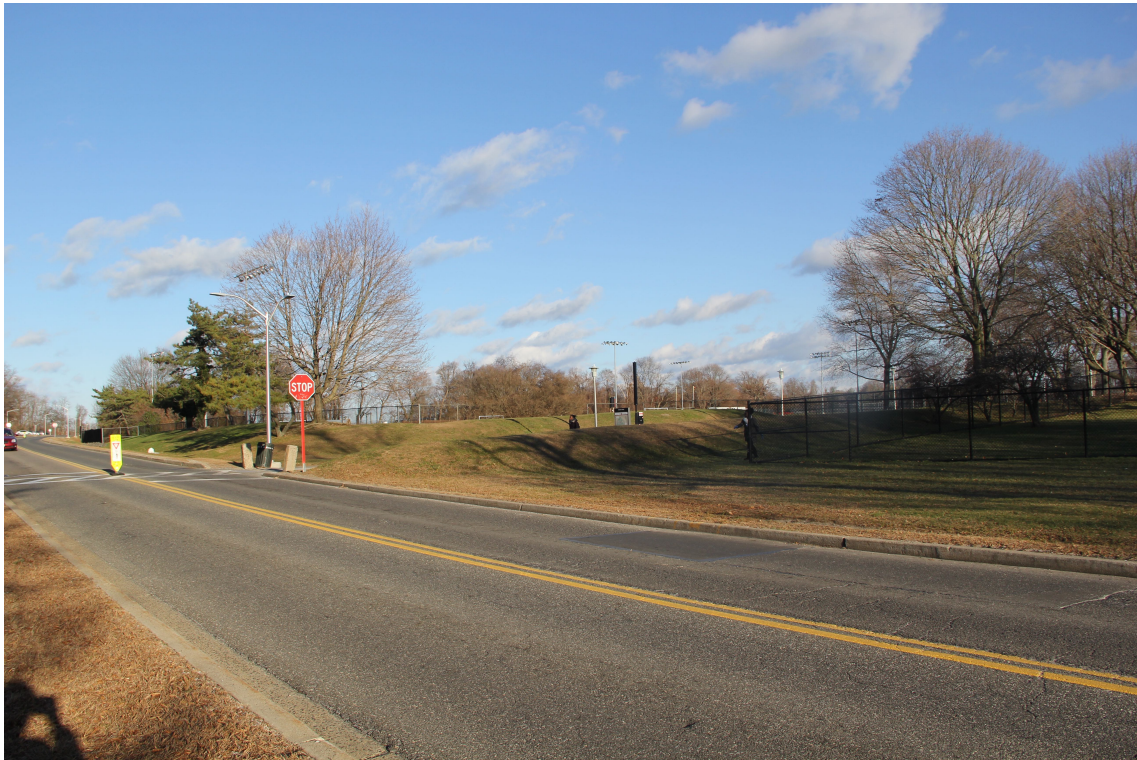
We count the crossings from the east. For a driver turning right from the North Entrance to the University, the crossing in question is the second crossing; for eastbound traffic it is the third stop sign starting with Gymnasium Rd. A view from the west is shown in Figure 1. The pedestrian path runs along the athletic fields to the north end of the Stadium lot (Figure 2). The path is heavily used by bicyclists; there is a Wolf Ride Bike Share station on the east side of the path.

As is clearly visible in the figures, there is a berm on the west side of the pedestrian path. This partially obstructs the visibility of approaching pedestrians to an eastbound vehicle driver. Note that the pedestrian in Figure 1 is partially obscured by the berm. In general, during daylight hours, and for foot traffic, the crossing is safe. During daylight hours vehicular drivers can see approaching bicycle/skateboard traffic irregardless speed. However, the crossing is potentially unsafe after dark for bicyclists or skateboarders, especially for those wearing dark clothing who do not slow down when approaching the crossing.

Figure 1: The view looking east from the bike path adjacent to the eastern end of the train station. The crossing is clearly marked.

A traffic calming device should be placed at the end of the pedestrian path to encourage bicyclists/skateboarders to slow down or dismount prior to reaching the crossing

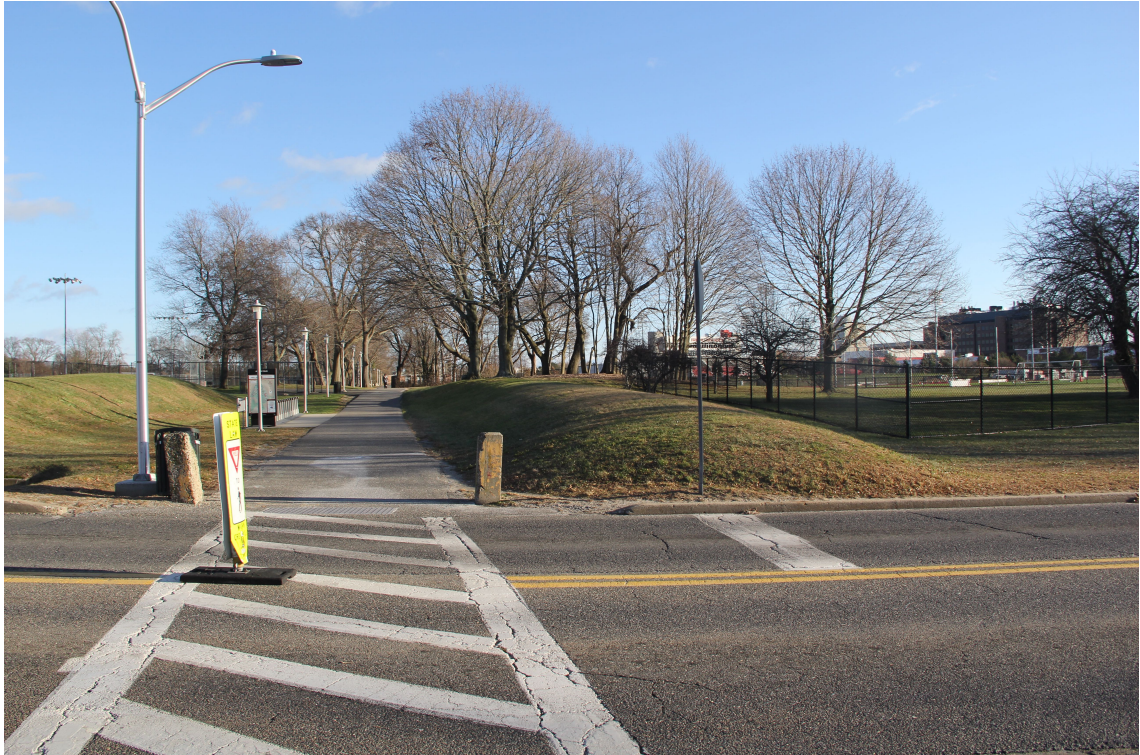
Figure 2: The view looking south along the pedestrian path. The Wolf Ride Bike Share station is visible on the east side of the path behind the campus map. The raised berm is on the right (west).

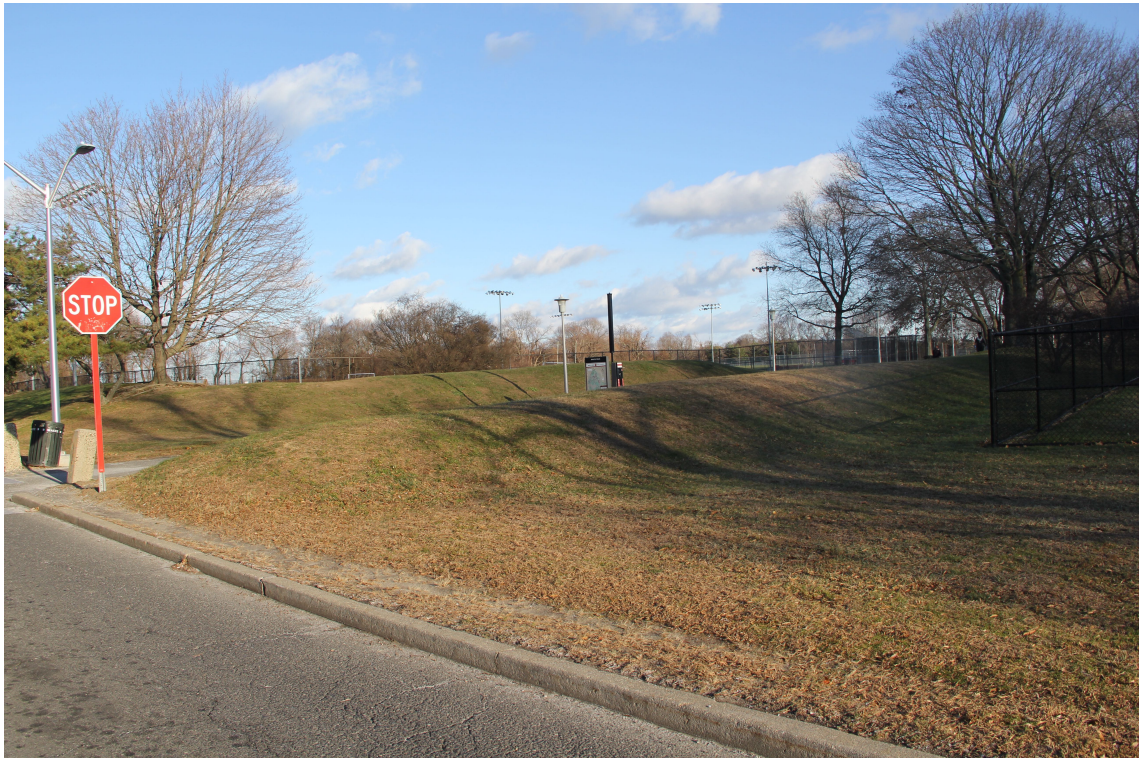
Figure 3: The view looking east towards the crossing. This approximates the view that an eastbound driver will have when approaching the stop sign. The Wolf Ride Bike Share docks are hidden behind the berm.
